# Flood-Fighting Structures Demonstration and Evaluation Program: Laboratory and Field Testing in Vicksburg, Mississippi

Fred Pinkard, Thad Pratt, Donald Ward Tina Holmes, Julie Kelley, Landris T. Lee, George Sills, Eric Smith, Perry A. Taylor, Nalini Torres, Lillian Wakeley, and Johannes Wibowo July 2007

#### Final report

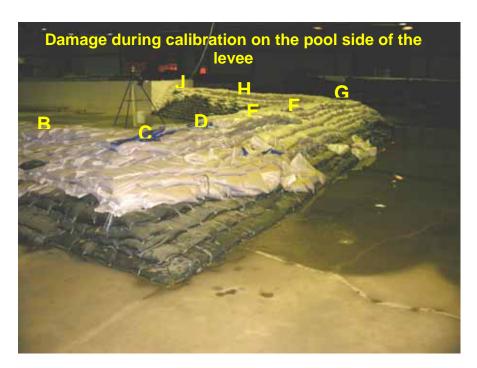
7- to 9-in. wave test, reservoir level at 66 percent levee height. This test was actually performed after the 10- to 13-in. wave test (due to operator error). The water level in the reservoir on the pool side of the sandbag levee was held at 24 in., and the wave heights were increased from 7 in. to 9 in. for a period of 10 min. The test was then stopped for about 15 min between each of the three test increments to allow stilling of the basin. Seepage flow rates ranged from 0.23 to 0.32 gpm/lft and no displacement was observed during the tests. No major overtopping occurred, however, the seepage did increase slightly during each 10-min test as is shown in Figure 2-30. Two sandbags were displaced into the pool from the middle of the structure.

Figure 2-27. Damage done during calibration of wave machine

Figures 2-27 and 2-28 and accompanying text show and explain the failure that required rebuild. A four-man crew took 11 hr (total 44 man-hours) to repair the damage. The rebuild was required from calibration needed to establish the limiting wave forces for all future tests. For this reason, the rebuild is not considered part of the test repairs.

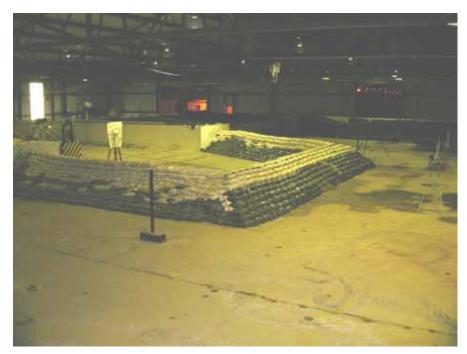
Figure 2-28. Sandbag levee after repair

coloring the water red from the fines leaching out of the sand. During the calibration of the 7-in. waves, more discoloration of the water was noticed. Sandbags were washed away from the side and the top of the center of the structure. Figure 2-27 shows that sandbags moved between point c and point g. The structure was rebuilt and the top of the levee was leveled. Because this happened in calibration of the wave machine prior to the actual testing, it is called a rebuild. This calibration was for all products to follow and was not part of normal testing. Total rebuild time was 11 hr with four people or 44 manhours. The levee after the rebuild is shown in Figure 2-28.

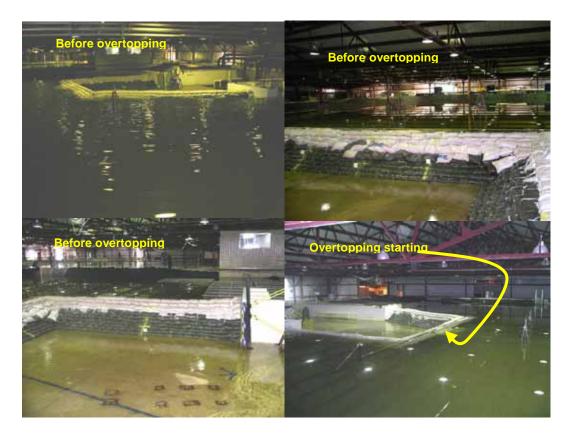
Figure 2-37. Sandbag levee prior to overtopping

The levee failed during overtopping before the pool elevation reached 37.5 in. The pumping rate continually increased until failure occurred. Thus, the structure failed before the test criterion was reached. Figure 2-37 shows the structure prior to testing. Figure 2-38 shows the progressive failure during overtopping. Figure 2-39 shows the sandbag levee after failure. The autopsy of Figure 2-40 shows that the bags became filled with water by the wave action and emptied as the sand flowed out like water (liquefaction). The wave action caused the untied bags to empty. Once the sandbags became light enough, the waves washed the bags from the levee causing failure. Some of the bags found on the landside were completely empty.

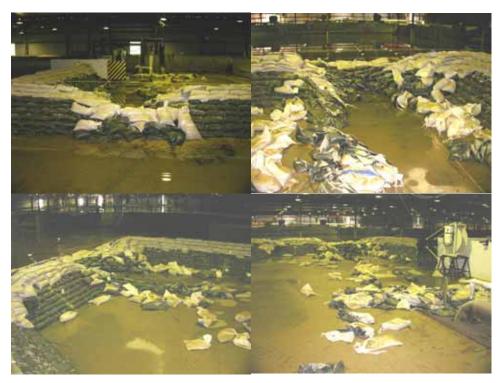
However, the pool overtopped the levee at an elevation of 37 in. (approximately 1 in. above the crest), and continued for a period of 5.7 min. Progressive levee failure occurred as the total flow rate increased from 30.3 to 96.0 gpm/lft. A total flow rate of 2450 to 7,760 gpm is shown in Figure 2-36. Failure and results of failure are shown in Figures 2-37 through 2-40.

Figure 2-39. Sandbag levee after failure

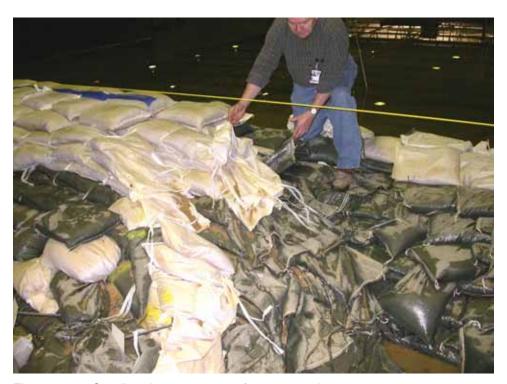
Figure 2-40. Sandbag levee autopsy after overtopping

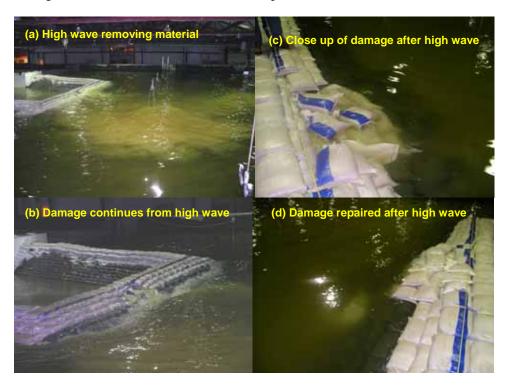
The levee experienced damage at the center section. Sandbags were pulled back into the pool as the waves overtopped and water rushed back into the pool as the waves moved back toward the wave machine. Figure 2-41 shows the levee during the test, the damage after the test, and the levee after Repair 1.

Figure 2-41. Sandbag levee damage and levee after field repair 1

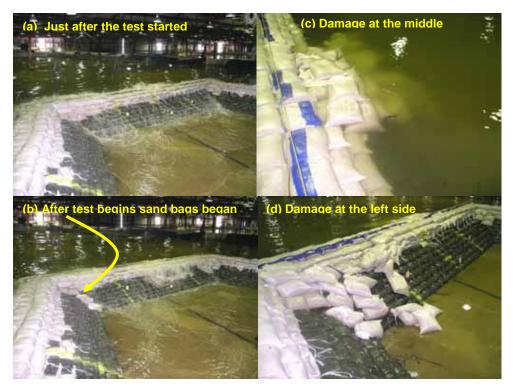
Figure 2-42. Damage to levee during the 10- to 13-in. waves, water at 80 percent of barrier height

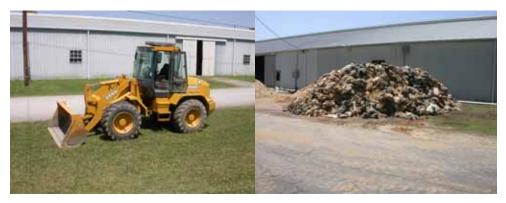
Figure 2-43. Heavy equipment used to disassemble sandbags and waste sandbags

The sandbags were broken and torn during removal and were not fit to be used again. The sandbags were piled into one large stack, similar to that seen in real-world flood fights. The equipment and sandbag pile can be seen in Figure 2-43.

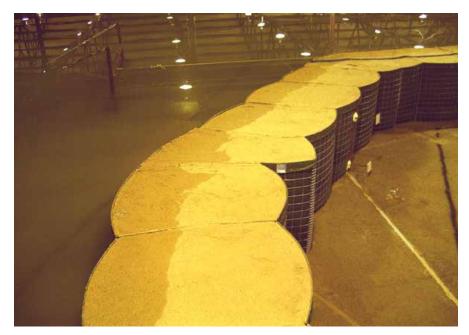
Figure 2-63. View of left wall water saturation

Figure 2-63 shows the wetting front observed on top of the structure as the water saturated the dry sand. Figure 2-64 is a close-up of seepage occurring at a vertical joint between units.

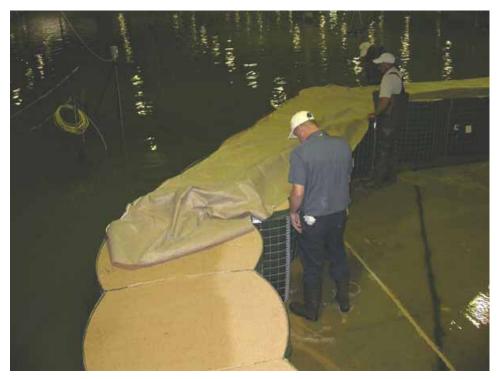
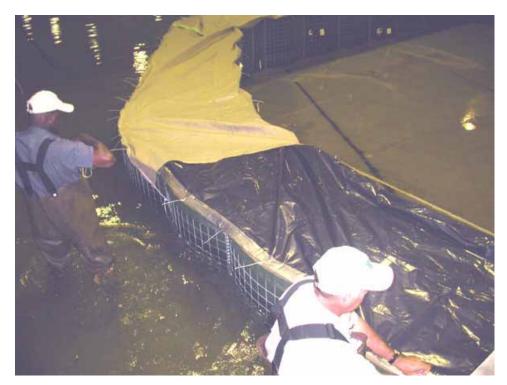
Figure 2-74. Covering top of wall with tarp to prevent further erosion

Figure 2-75. Securing with cable ties

At the conclusion of the test, sand had eroded and settled from the top of the center wall (Figure 2-73), and a solution was devised to prevent further erosion during subsequent testing. As shown in Figures 2-74 and 2-75, a tarp covering was placed on the wall top and secured with cable ties.

Repair 1 was performed prior to the 80 percent small (2- to 3-in.) wave test. It consisted of adding a top membrane fabric over the units, and adding cable ties and wire ties. A four-man crew took 24 min (1.6 man-hours) to do this work. Figure 2-87 shows this work (see also Figures 2-74 and 2-75).

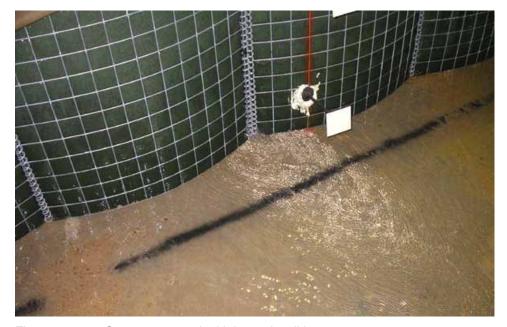
Figure 2-77. Seepage at vertical joint and wall base

was activated, and the waves began to impact the levee. Flow rate was observed to range from 1.03 to 1.04 gpm/lft (Figure 2-76), with no displacement. No wave overtopping was observed. Figure 2-77 shows seepage under the center wall base.

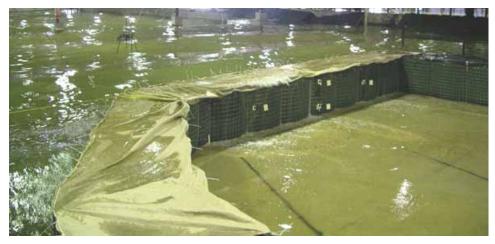
Figure 2-81. Wave overtopping along center wall

10- to 13-in. wave test, reservoir level at 80 percent levee height. The water level in the reservoir on the pool side of the levee was held at a height of 29 in., the wave generator was activated, and the waves began to impact the levee. Flow rate was observed to range from 1.05 to 3.14 gpm/lft (Figure 2-80), with no displacement. Wave overtopping was observed at each wave front, which contributed to the significant flow rate increase. Figure 2-81 shows wave overtopping.

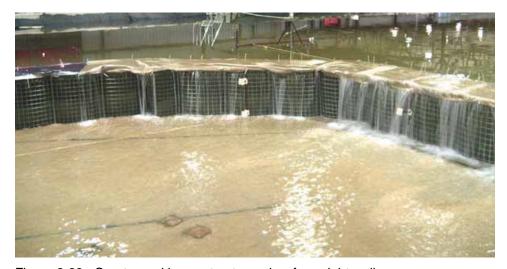
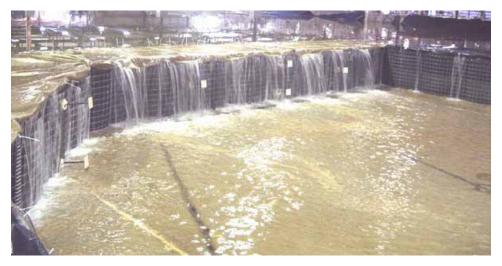
withstood overtopping without failure. Overtopping water combined with seepage water to increase the measured flow rate within a range of 25.2 to 35.0 gpm/lft (1,800 to 2,500 gpm) in the span of 1 hr as shown in Figure 2-82. The overflow was uniform due to the uniform levee height. Figures 2-83 and 2-84, show the overtopped levee.

Figure 2-83. Overtopped levee structure, view from right wall

Figure 2-84. Overtopped levee structure, view from left wall

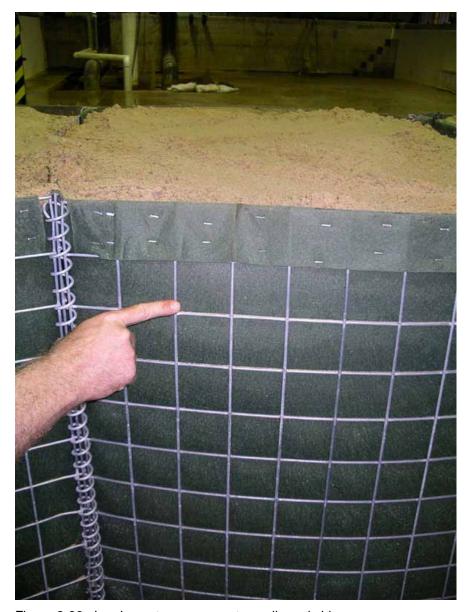
With reservoir level at 24 in., the log impact tests were begun. The 12-in. log impacted the structure and bounced back without causing noticeable damage. The structure displaced slightly and recovered to its original position. The 16-in. log impacted the structure and bounced back also without causing any noticeable damage. The structure displaced slightly and recovered to its original position, but vertical deformations of the sand fill ranging from 4.02 to 0.72 in. were noted. Figure 2-85 shows the minor change in seepage flow rate during impact testing and Figure 2-86 shows the area where the logs hit, viewed from the pool side.

Figure 2-86. Log impact zone on center wall, pool side

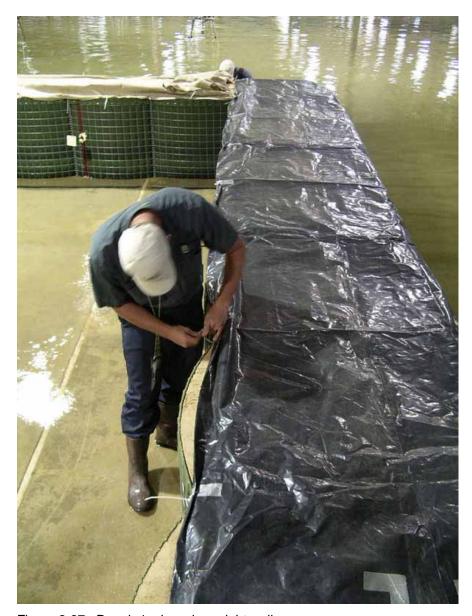
Figure 2-87. Repair 1, view along right wall

Repair 2 was performed prior to overtopping. It took three men 5 min (0.25 manhours) to add prefilled sandbags on the pool side for additional protection against joint seepage (Figure 2-88). Repairs 3 and 4 were not needed.

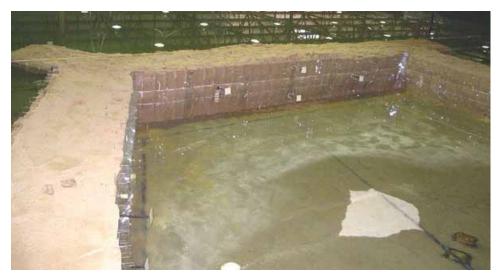
**Hydrostatic head test, 3-ft reservoir (95 percent height)**. The water level in the reservoir on the pool side of the levee was raised to a height of 34 in. (95 percent of levee height) as shown in Figure 2-133. Seepage flow rate was measured in the range from 0.084 to 0.108 gpm/lft (Figure 2-134), and no displacement was observed. Figure 2-135 shows that most of the leakage was observed coming from the wall corners. Figure 2-136 shows settlement along the right outside edge.

Figure 2-135. View of seepage under structure

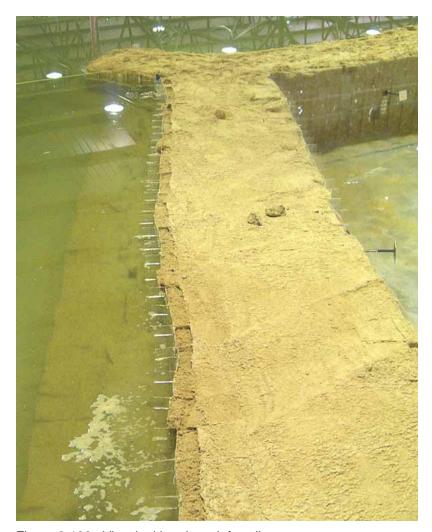
Figure 2-136. View looking down left wall

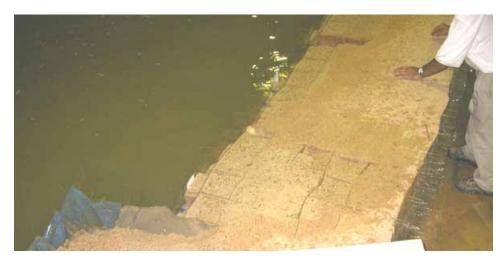
displacement was observed. Overtopping did occur sporadically, which contributed to the flow rate increase. Figure 2-143 shows aftermath of wave action against the left wall near the concrete wall abutment. Minor surface erosion was evident.

Figure 2-143. Surface erosion from wave action

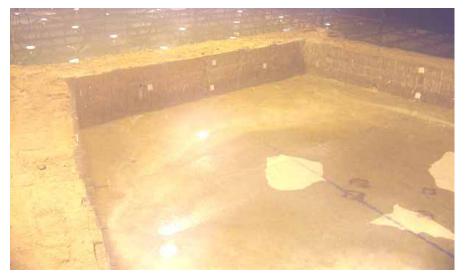
**3-in.** wave test, reservoir level at 80 percent levee height. The water level in the reservoir on the pool side of the levee was raised to a height of approximately 29 in., the wave generator was activated, and the waves began to impact the levee. Seepage flow rate was measured in the range from 0.039 to 0.046 gpm/lft (Figure 2-144), and no displacement was observed. No overtopping was observed, but some surface sand settling was observed (Figure 2-145).

Figure 2-145. View immediately after test showing some sand settling on left wall surface

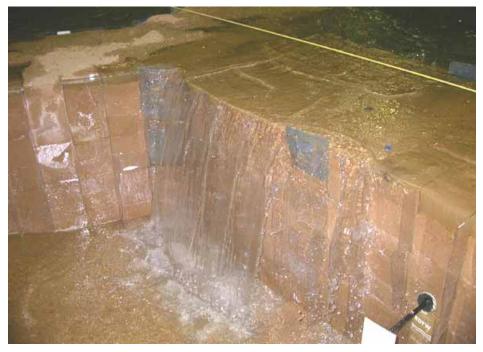
**7- to 9-in. wave test, reservoir level at 80 percent levee height**. The water level in the reservoir on the pool side of the levee was held at a height of 29 in., the wave generator was activated, and the waves began to impact the levee. Seepage flow rate was measured in the range from 0.048 to 4.48 gpm/lft (Figure 2-146), and no displacement was observed. Overtopping did occur sporadically, which contributed to the flow rate increase (Figures 2-147 and 2-148).

Figure 2-147. Sporadic wave overtopping at intersection of left and center walls

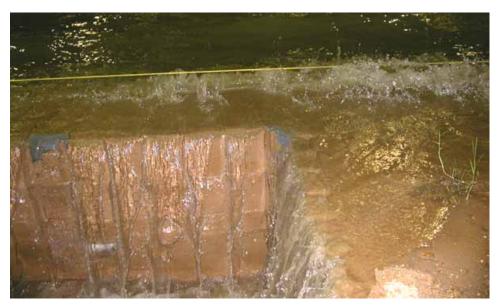
Figure 2-148. Sporadic wave overtopping at intersection of right and center walls

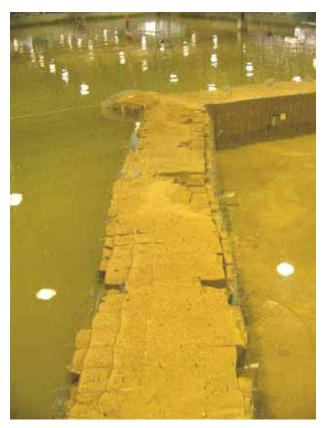
At the conclusion of the test, the condition of the levee structure was observed. As seen in Figures 2-149 and 2-150, minor surface erosion resulted from the sporadic wave overtopping action.

Figure 2-149. Surface erosion on left wall at conclusion of test

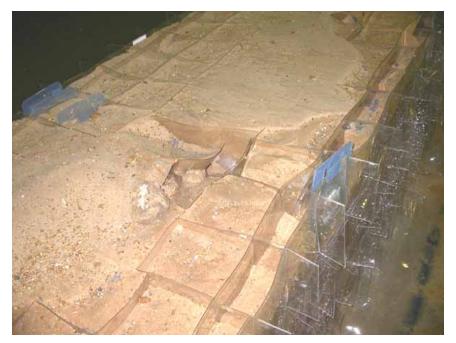
Figure 2-150. Close-up of surface erosion on left wall

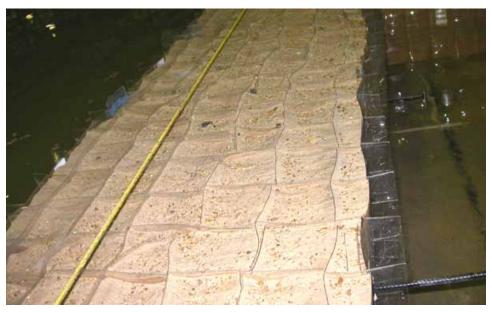
Figures 2-154 and 2-155 are close-ups of the surface erosion observed at the test conclusion.

Figure 2-154. Close-up of center wall after test was concluded

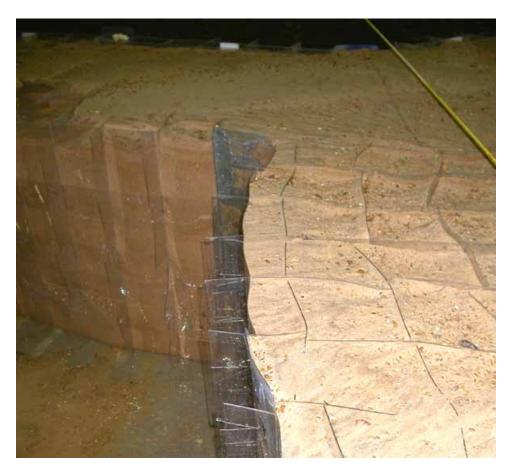
Figure 2-155. Close-up at intersection of left and center walls

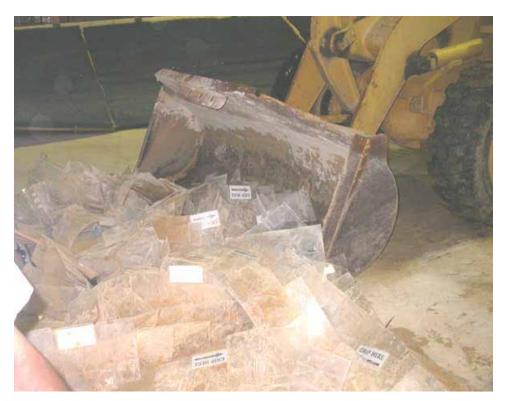
Due primarily to the effects of disassembly, approximately 10 percent of the plastic material was nonreusable and nonrepairable. According the manufacturer's literature, normally-anticipated breakage is repaired by replacing the broken grid unit piece or by reinforcing the broken piece. Manufacturer stipulations apply regarding reusability and placement of repaired grid units back into service.

Figure 2-183. Some nonreusable grid units

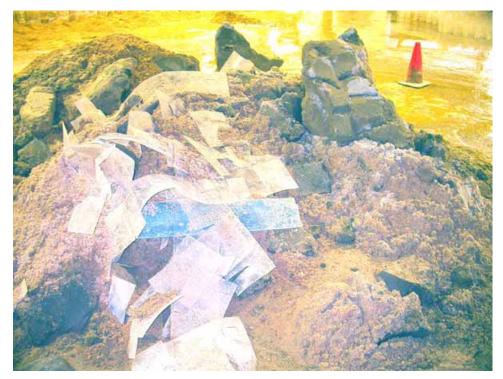
The preceding sequence was repeated for each grid unit layer until the entire levee structure was disassembled. Figures 2-178 through 2-182 are views of the remainder of levee removal. Assistance from the small front-end loader achieved greater removal speed, but decreased the reusability of the grid units due to damage. Figure 2-184 shows a debris pile of nonreusable grid units mixed with sand and sand/cement materials.

Figure 2-184. Nonreusable grid units, sand, and sand/cement mixture ready for disposal

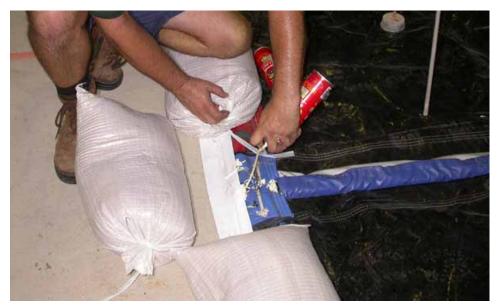
At the end of the joined vinyl tarp sections, expandable foam was used to seal against any possible water leakage. The apron edge sandbag was then placed back into position (Figure 2-208).

Figure 2-208. Expandable foam treatment at vinyl tarp apron edge

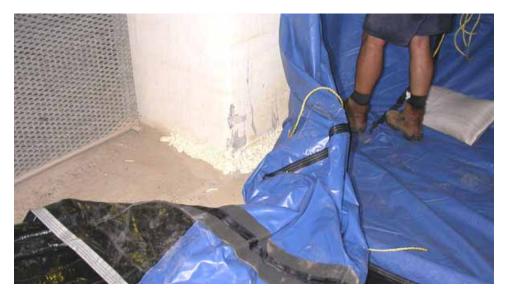
At each concrete wingwall abutment, a can of expandable foam was sprayed on the concrete wall/floor junction and the tarp was pushed against the wall. A vertical  $2 \times 4$  was placed to hold the tarp against the wall, and sandbags were placed against the wall (Figures 2-209 and 2-210). The total number of sandbags placed inside the steel frames, over the apron edge, and at wall abutments was 178.

Figure 2-209. Expandable foam treatment at concrete wall abutment

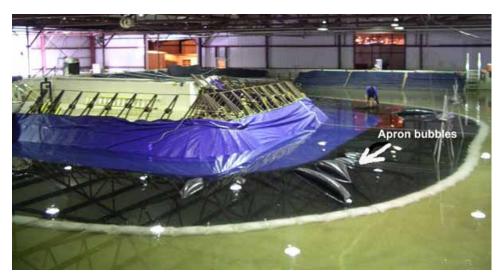
**Hydrostatic head test, 1-ft reservoir (33 percent height)**. The water level in the reservoir on the pool side of the levee was raised to a height of 1 ft (33 percent of levee height). As the initial pool elevation began to rise, some air pockets under the apron were observed. The supervisor walked out and placed a few sandbags on these air pockets to flatten them out (Figure 2-215). The barrier had very little water seepage, ranging from

Figure 2-215. Air bubbles beneath apron

Repair 1 occurred after the 33 percent hydrostatic test. The remainder of air pockets beneath the apron were flattened out by walking down and/or placing a sandbag on the air pocket. One supervisor took 30 min for this repair (0.5 man-hours).

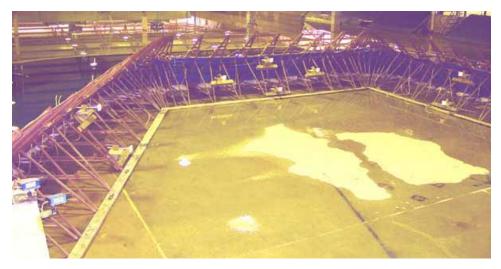
0.08 to 0.11 gpm/lft (Figures 2-216 and 2-217). Zero displacement was observed. Prior to the next test, Repair 1 was performed (discussed in the following paragraphs).

Figure 2-216. Under-apron seepage at 1-ft hydrostatic test

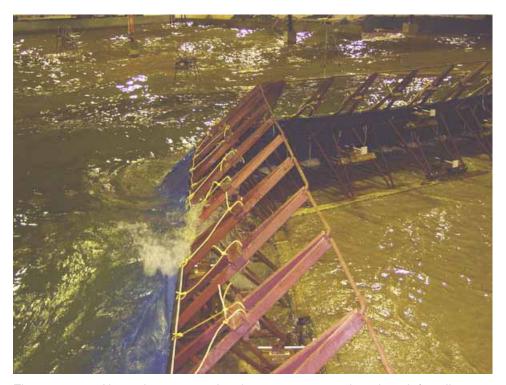
Figure 2-230. Aborted wave test showing wave overtopping along left wall

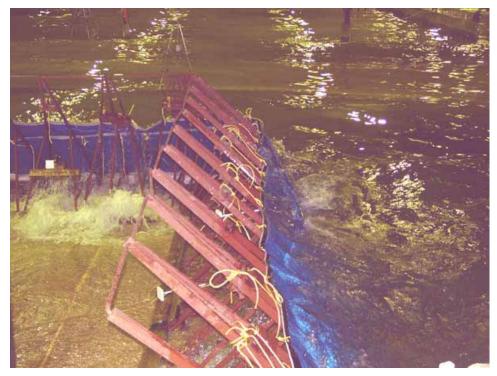
The 7- to 9-in. test were conducted within a few minutes after the wave basin was stilled from the aborted test. Wave run-up and overtopping contributed to raising the seepage pit flow rate from the rate of 0.175 to 10.72 gpm/lft (Figure 2-231). No displacement was noted. Figure 2-232 shows typical wave overtopping.

Figure 2-232. 7- to 9-in. wave test showing wave overtopping

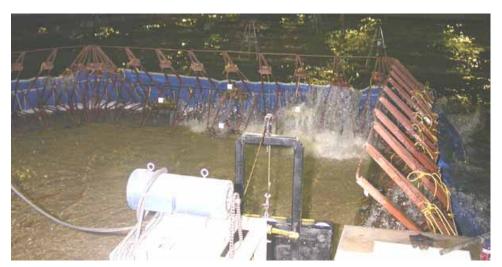
**10- to 13-in. wave test, reservoir level at 80 percent levee height**. The water level in the reservoir on the pool side of the levee was held at a height of 29 in., the wave generator was activated, and the waves began to impact the levee. Flow rate increased from 0.175 to 20.43 gpm/lft (Figure 2-233) due to wave overtopping. Figures 2-234 and 2-235 show the test in progress. No displacement was observed.

Figure 2-234. 10- to 13-in. wave test showing wave overtopping along center wall (partial view of impact test apparatus)

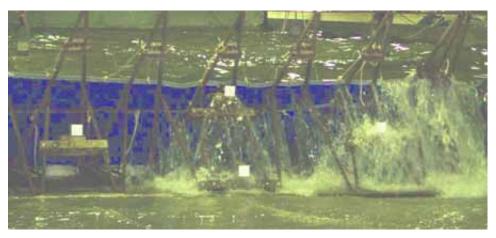
Figure 2-235. 10- to 13-in. wave test showing wave overtopping along center wall

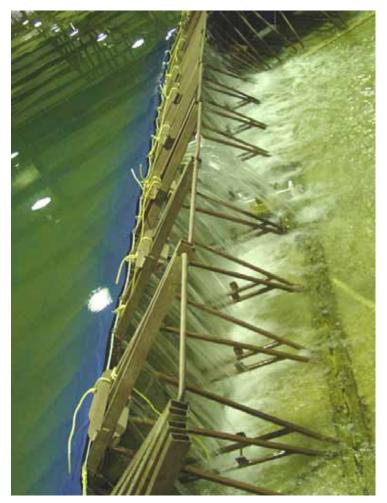
The water level was slowly raised to 40 in. (approximately 1 in. higher than the highest edge of the tarp) and held for 1 hr while overtopping occurred. Total flow rate due to overtopping ranged from 78.8 to 80.3 gpm/lft (5,400 to 5,500 gpm/lft) as shown in Figure 2-236. The large flow can be contributed to the sagging membrane between frames, which makes low points all along the levee. There was no barrier failures were observed during the test. No displacement was noted. Figures 2-237 and 2-238 show overtopping.

Figure 2-237. View of overtopped left wall

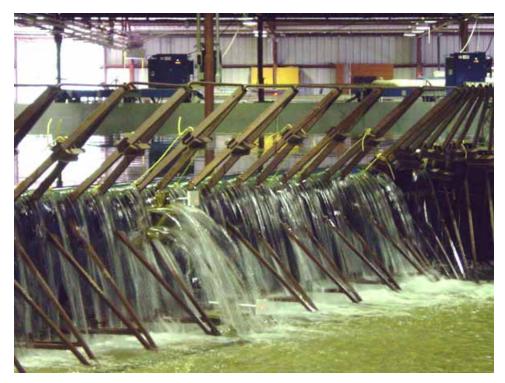
Figure 2-238. Center wall overtopping

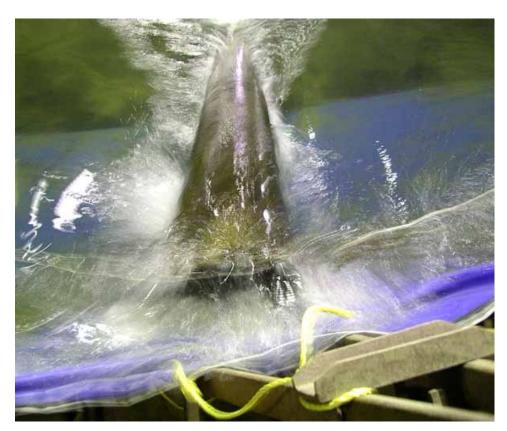
The water level was slowly dropped to the 66 percent height (2 ft) while preparations were made for the log impact test. The small-diameter log (12-in.) struck the tarp (Figure 2-239 and created a one-eighth-in. diam hole (Figure 2-240), resulting in insignificant additional leakage until the larger log impacted the structure as described in the following paragraphs.

Figure 2-239. Log impact

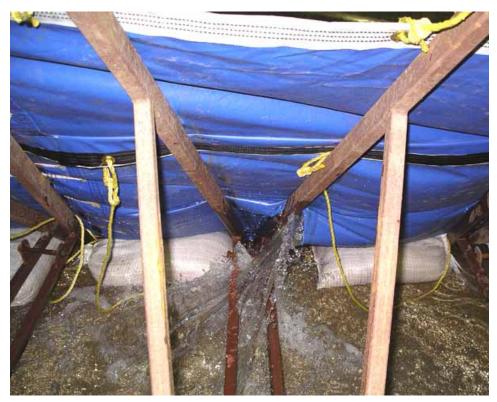
The larger diameter log (16-in.) struck the tarp about 3 ft to the left of the trajectory path, and created an 8-in.-long vertical slit (gash) in the tarp at the waterline (Figure 2-241) at a steel frame member. The gash increased the flow rate, but no structural failure or displacements due to impact were observed. Due to the ripstop ability of the vinyl tarp, the slit size did not increase (Figure 2-242), and the inflow seepage remained constant at around 3.5 gpm/lft (Figure 2-243). The seepage due to the tear remained constant until the pool elevation was lowered at the test conclusion, also shown in Figure 2-243.

Figure 2-241. Water inflow after large log impact

Repair of the impact damage was not pursued or performed, so Repair 3 was not needed. The Portadam® representative was not onsite during the log impact test, the damage appeared to have no probability of contributing to progressive failure or increased leakage, and a field repair would have served no useful purpose since the testing program had concluded.

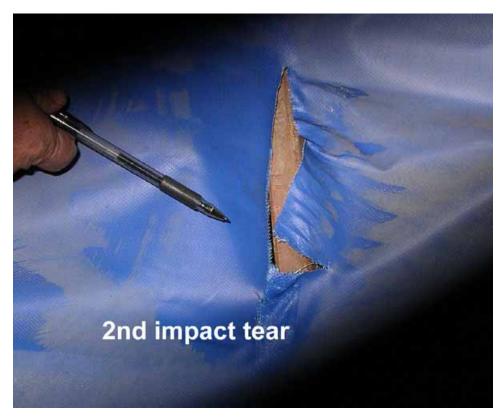
Figure 2-242. View of gash caused by large log. Note frame member behind slit

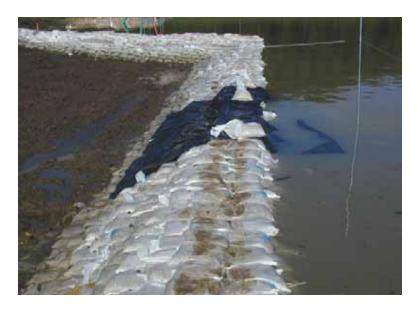
Figure 3-56. Plastic sheeting over riverward face

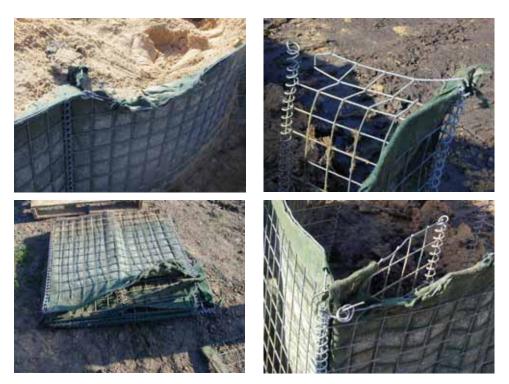
Figure 3-104. Units damaged during removal process

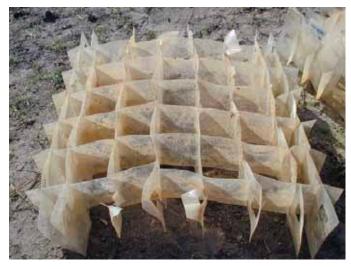
Once removed, the RDFW units were inspected for damage. Some damage to the units was identified (Figure 3-144). The most damage was to the top row, bottom row, and the end units. Some individual panels of these units could be saved with the damaged pieces being replaced. Once the damaged pieces are replaced, the unit is reusable. Each RDFW unit consists of 14 pieces. Geocell Systems conducts a replacement procedure that they term "cannibalize" the units. This procedure includes the removal and replacement of damaged pieces within a unit with undamaged pieces to make the unit reusable. While minor damage was sustained during testing from the units shifting against the weight of the water, most of the damage to the RDFW units occurred during removal. Damage to the bottom units was attributed to the use of heavy machinery. By approximate field estimates, approximately 90 percent of the units were reusable.

Figure 3-144. Damaged RDFW unit

The units can be cleaned by washing the sand, mud, and debris off with a garden hose. However, they were not cleaned during this project. The used units that were not damaged or could be repaired (cannibalized) were folded flat and returned to the wooden crates. The units damaged beyond repair were disposed of.

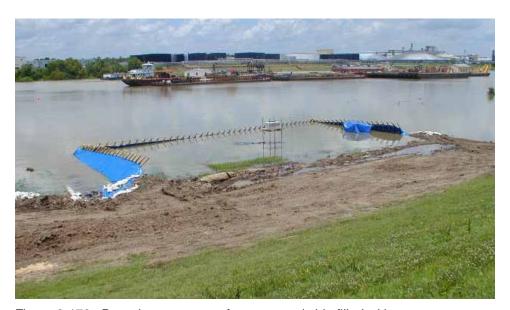
Figure 3-176. Portadam structure after protected side filled with water
